San Joaquin Rail Corridor Crossing Survey

**California PATH Research Report
UCB-ITS-PRR-2008-6**

Final Report for Task Order 6201

June 2008

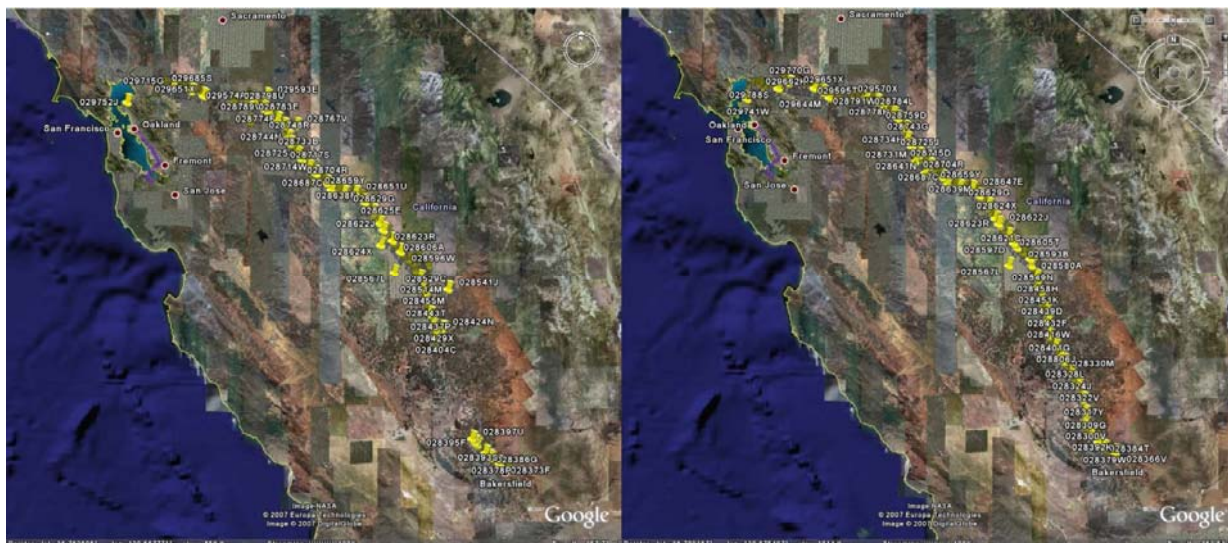
Figure 1: Plot of original crossing database locations (left) and final database locations (right). The leftmost picture has several “gaps” compared to the one on the right. On this scale, however, the gap that can most clearly be seen is in Kings County in the southern portion.

The current staff of the Visual Detection Laboratory were supplied a database (in spreadsheet format) that had over 500 crossing entries but we subsequently discovered that, while the number was a good deal higher than the 397 crossings quoted in the original proposal, the database was still very incomplete. We discovered this by extracting the latitude and longitude from the original database and plotting the results in Google Earth. See Figure 1 below.

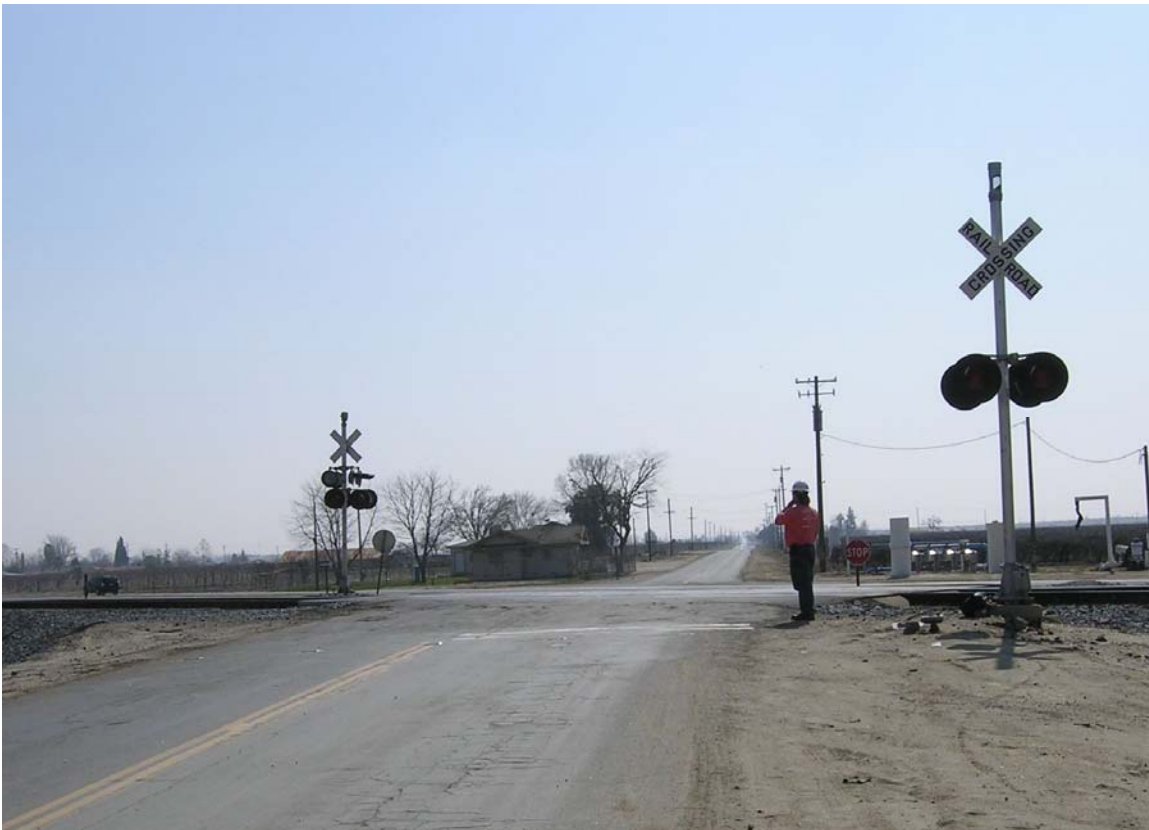
Figure 8: Grade crossing at Poplar Avenue looking south. The (five) embedded lights under test run across the width of the road parallel to the white limit (double) line and just north (foreground) of it. Other than being too far to the right, the perspective of this photograph is approximately that of a driver approaching the grade crossing.

The actual layout can be seen in the next two figures. The pictures were taken looking south along Poplar Avenue just north of the railroad tracks and Highway 43. The light housing at the end of the double yellow centerline just short of the left end of the white limit (double) line can be seen fairly easily in the first picture. The two lights to the left of this one (northbound side of Poplar) are less easily seen and the two to the right (southbound side) just before the white limit line are just barely visible in the photograph.

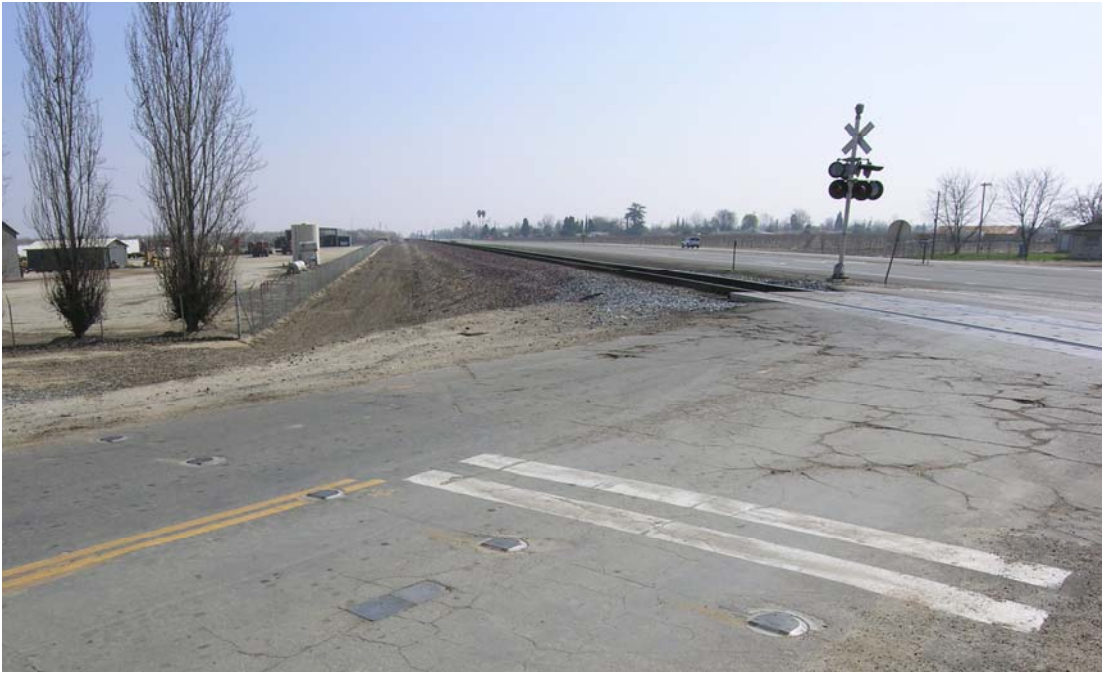
Figure 9: The same five embedded lights as seen from above and looking more easterly.

Figure 9 gives a better idea of the layout. The metal rectangle near the light in the middle of the southbound lane is the lid to a box containing an embedded magnetometer that was used in Mr. Lai's project.

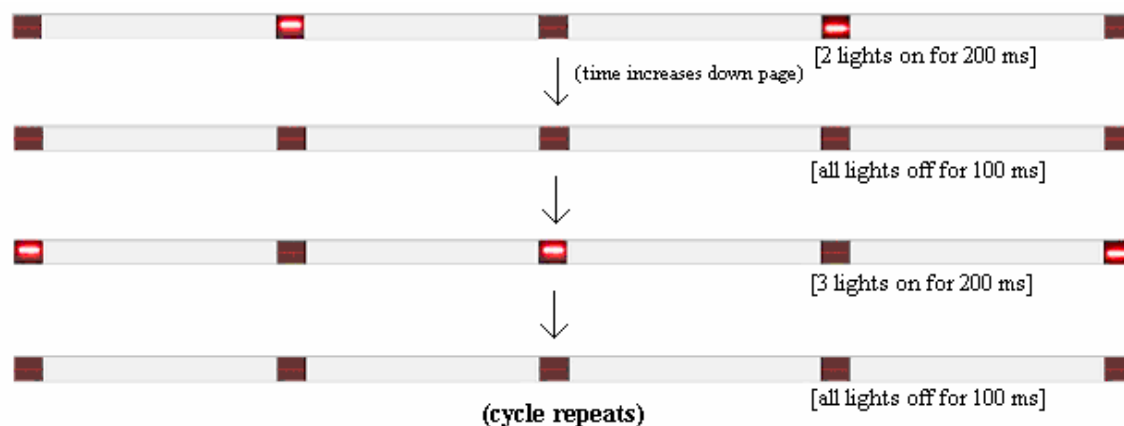
Figure 11: Pattern and timing for field-deployed lights

Based on previous laboratory experiments, the Visual Detection Lab felt that the signal pattern of the embedded lights could be changed so as to improve the signal’s effectiveness. The laboratory experiments had tested the reaction time of a number of observers who hit a response button upon seeing a given light pattern fire. Several patterns were tested. The best overall responses came from a pattern similar to that shown in Figure 11. (“Similar” because the lab test used four lights not five as shown here and the lighting sequence times were rounded off to those shown in the figure.)

We called the lighting pattern in Figure 11 the “Alternating Flashed Pair” (even though it consists of five lights) because it is very much like the flashing light pair used as the standard warning at railroad crossings. If the lights in this picture are thought of as being numbered from one to five as one moves left to right, then the pattern is basically the even numbered lights firing followed, after some “dead time”, by the odd numbered lights firing. The cycle then repeats.
